BALDWIN AUDITORIUM AT DUKE UNIVERSITY, DURHAM, NC

A Domed Homecoming

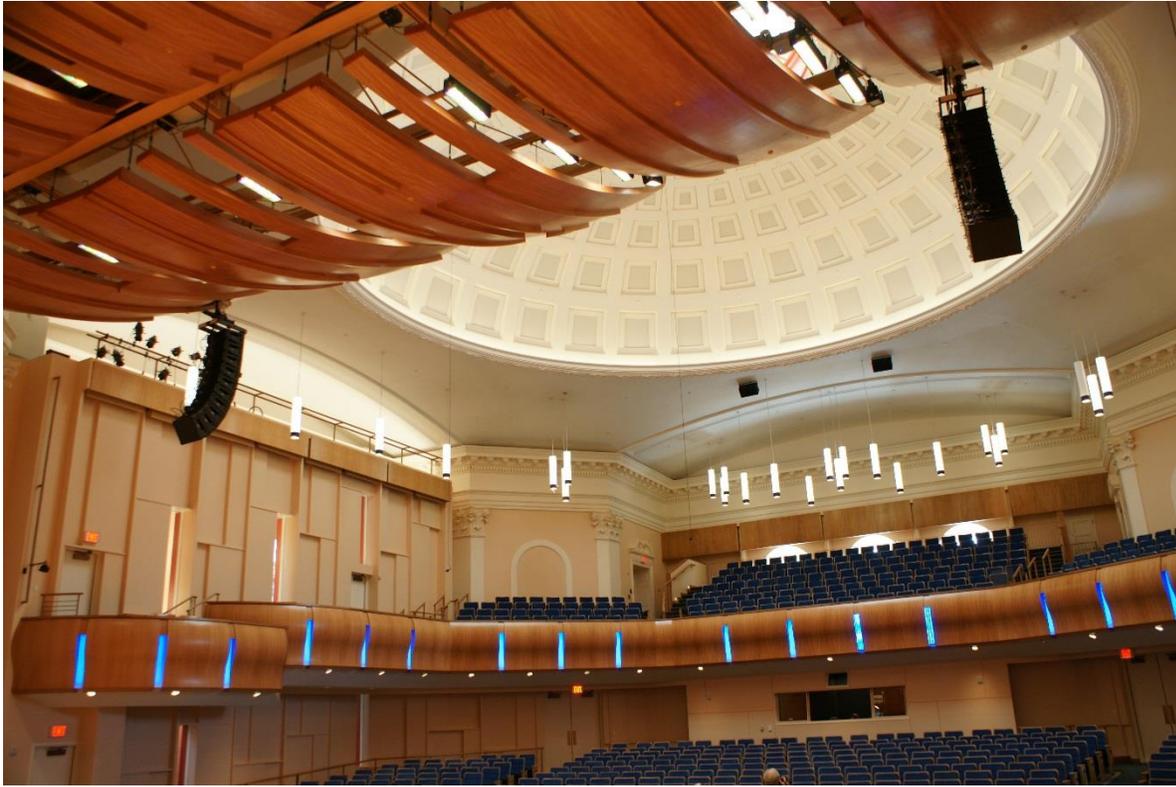
Baldwin Auditorium, Duke University, NC, renovated 2013. This renovation preserved the character of Baldwin Auditorium and enhanced intimacy, comfort, and acoustics.

The dome was treated with diffusive panels to transform it from a liability into an asset, while a dynamic new wood shell surrounded the stage and extended dramatically into the hall. Both rolling acoustic banners and horizontally tracking acoustic drapes were utilized.

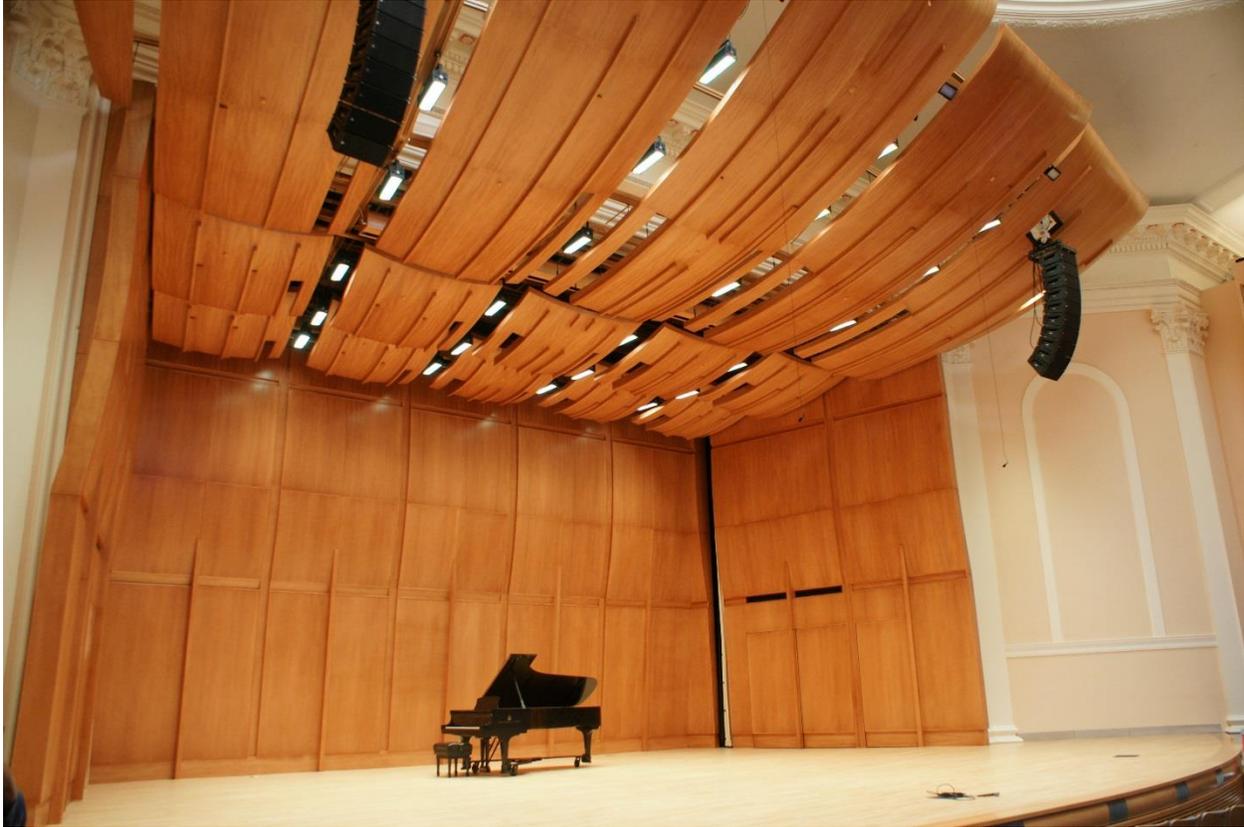
Baldwin Auditorium, Duke University, NC, renovated 2013. Stage Enclosure. Wood veneer plywood and MDF walls and ceilings are shaped for acoustic reflections, diffusion and blending. Openings in the ceiling reflectors are precisely positions for acoustic coupling to the volume above them.

The wood stage enclosure features double doors that allow for the free movement of performers, openings for stage air distribution, stage lighting, and line array speaker suspension points. The complex diffusive geometry was built of one inch (2.5 cm) thick double curved wood by a local furniture maker. It was built in large sections, then delivered and hoisted into position. The tight budget would not allow the inclusion of motorized winches to allow adjustability of the angle or height of the ceiling elements. We would have one shot at getting the angle right and it would need to be in the design phase.

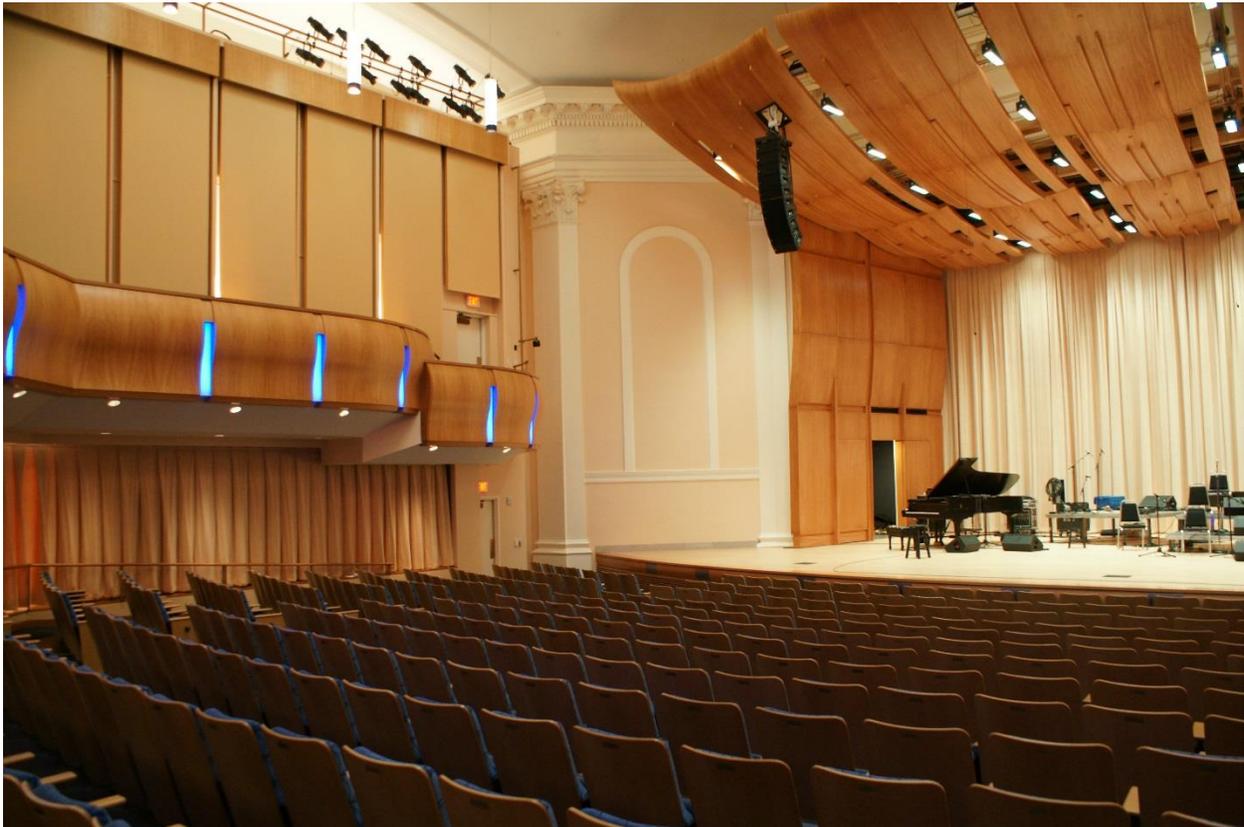
Baldwin Auditorium, Duke University, NC, renovated 2013. A view of the acoustic banners deployed on the upper side walls and tracked drapes under the balcony.

The location of the acoustic banners and drapes presented a challenge, as we did not want to penetrate the ceiling with banner boxes on account of access issues and limited space for the mechanisms above the ceiling. Therefore, the banners were placed on the side and rear walls in visually exposed banner boxes. The new side walls held more than just the banners. They also narrowed the hall to 90 feet (27.5 m) for improved C80 reflections and diffused sound with applied painted wood panels, vision lites and moldings. The banners are double layer wool serge (as described in Chapter 15) and drop down on double rollers to minimize the size of the exposed storage enclosure. The rear wall velour drapes pull up from floor mounted banner boxes.

A motorized traveler drape can cover the walls under the balcony on either side of the control booth. This is useful for controlling reflected sound from amplified events. A large manual acoustic drape covers the upstage wood wall for amplified productions and lecture use and can be stored inside pockets when not needed.

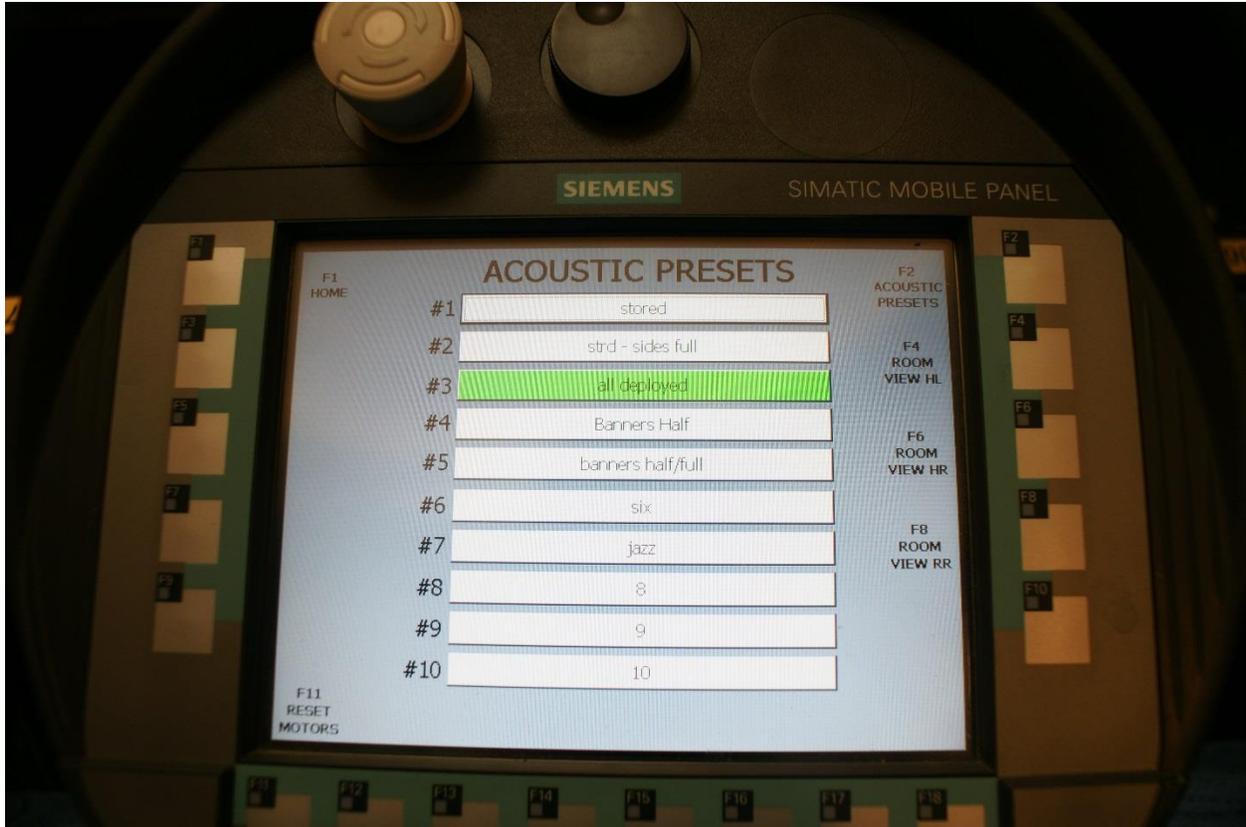
Baldwin Auditorium, Duke University, NC, renovated 2013. Adjustable acoustic control system has presets predetermined during our acoustic tuning. This allows users to easily access our preferred settings by performance type.

We provided an acoustic manual for this project to outline recommended settings of the adjustable acoustic elements for various types of programs in the auditorium. Note that all of the settings for the acoustic drapes and banners listed here have been recorded as presets in the rigging control module and are labeled accordingly for ease of use. In addition, performer stage locations were experimented with throughout the tuning process and the approximate recommended locations are described. For programs not included, the variable acoustic elements would be set and the performers located according to the event type they most closely resemble.
